The Design
and
Methods of Construction
of
Welded Steel Merchant Vessels

FINAL REPORT OF A BOARD OF INVESTIGATION

To Inquire Into
THE DESIGN
AND METHODS OF CONSTRUCTION
OF WELDED STEEL MERCHANT
VESSELS

15 JULY 1946

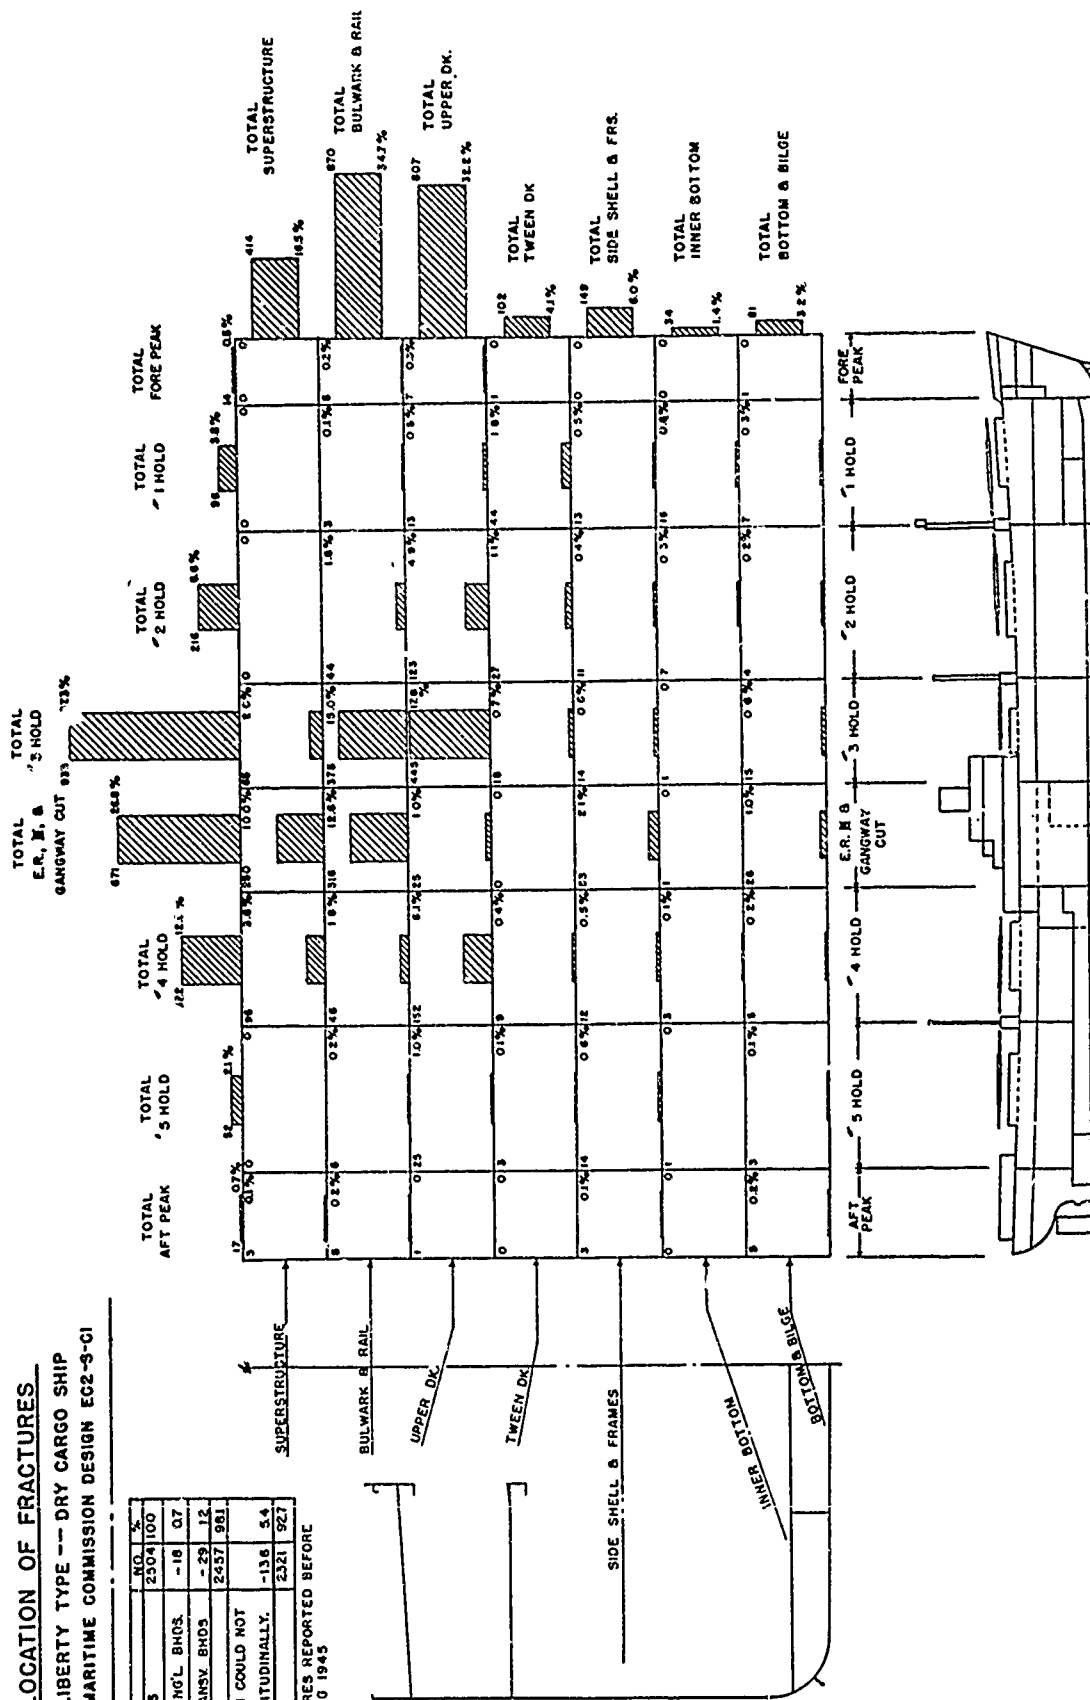
Fig. JTC 30.

A plot, figure 30, has been prepared showing the longitudinal and vertical location of all classes of fractures on the Liberty ships. This chart indicates that the fractures peak up near amidships in the upper deck and in the bottom with few fractures in the tween decks, indicating that longitudinal bending stresses play an important part in their distribution. The tabulation also shows the magnifying effect of certain design features such as the hatch corners which were responsible for 612 fractures or 24.4 percent. The sketch of the EC2-S-C1 vessel indicates the effect quite clearly, figure 31.

*NOTE: NUMBER IN THE UPPER LEFT CORNER OF EACH SQUARE INDICATES THE NUMBER OF FRACTURES THAT HAVE OCCURRED IN THAT PARTICULAR SECTION OF VESSEL. THE NUMERAL IN THE UPPER RIGHT CORNER INDICATES THE PER CENT OF THE TOTAL FRACTURES OF ALL SECTIONS (2504)

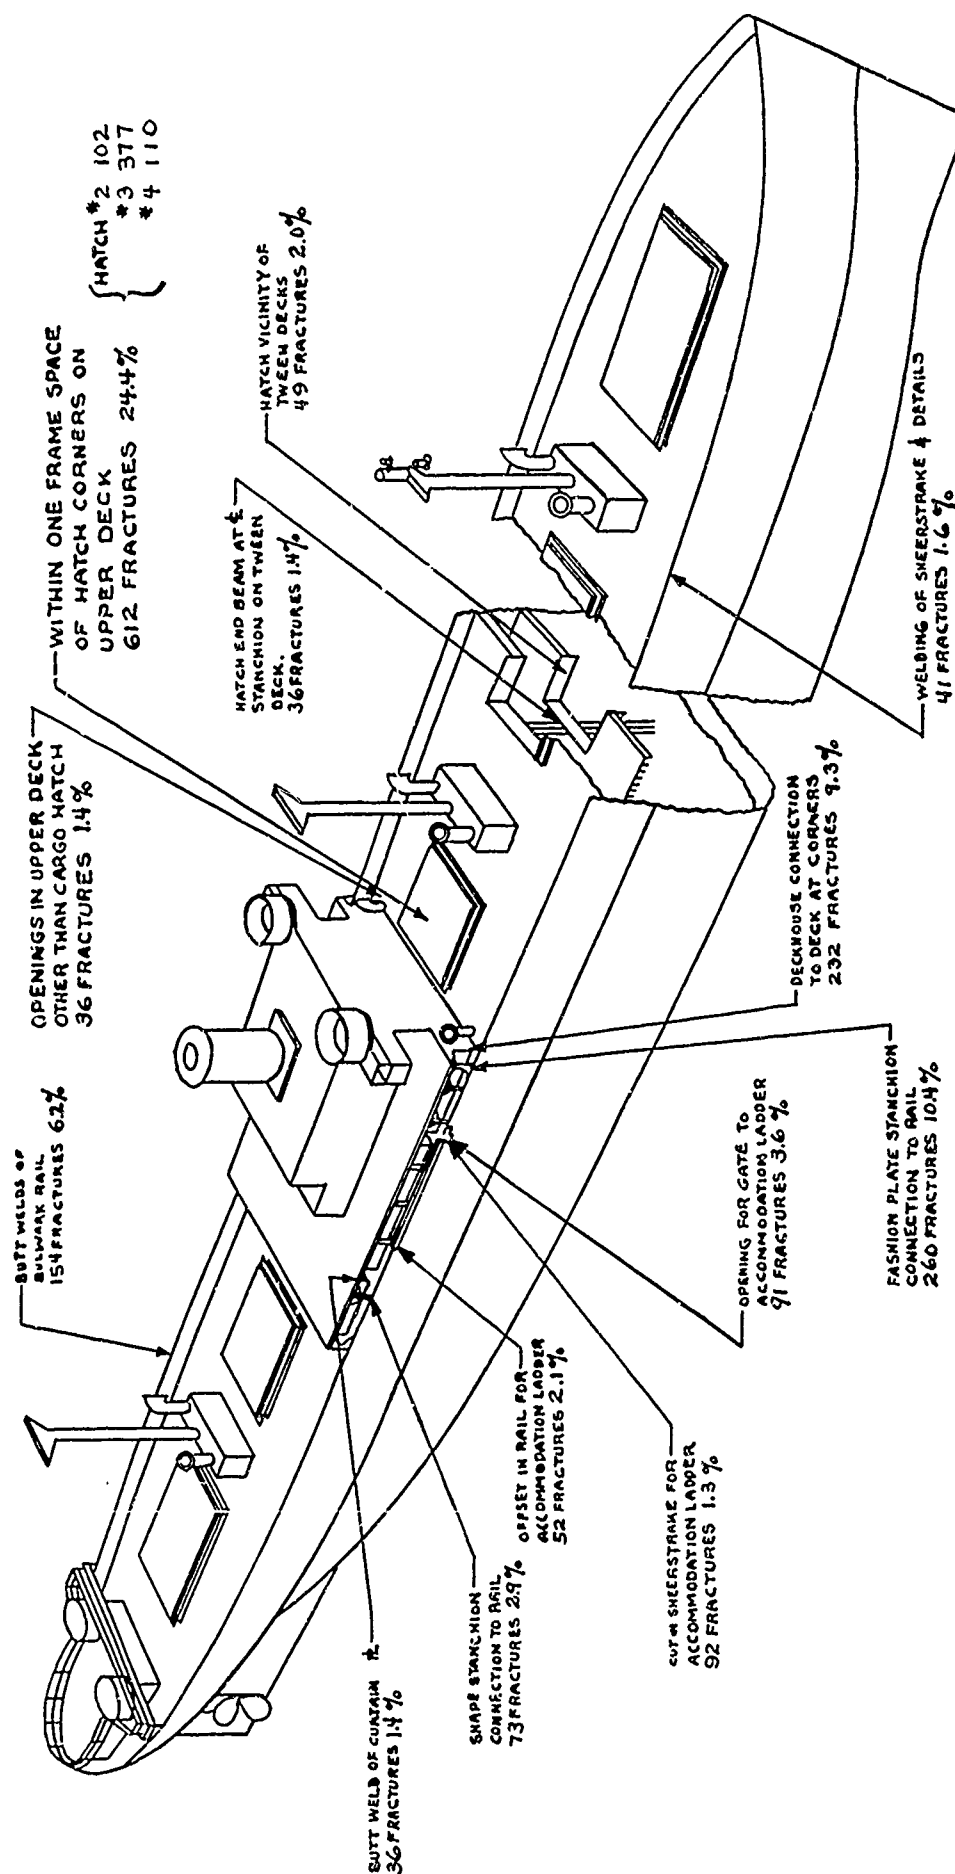
Figure 31.

DETAILS WITH ABNORMAL FREQUENCY OF FRACTURES

THESE DATA INCLUDE 2504 FRACTURES OF KNOWN ORIGIN, OCCURRING BEFORE 1 AUG. 45. 158 OTHER FRACTURES OF INDEFINITE ORIGIN WERE REPORTED

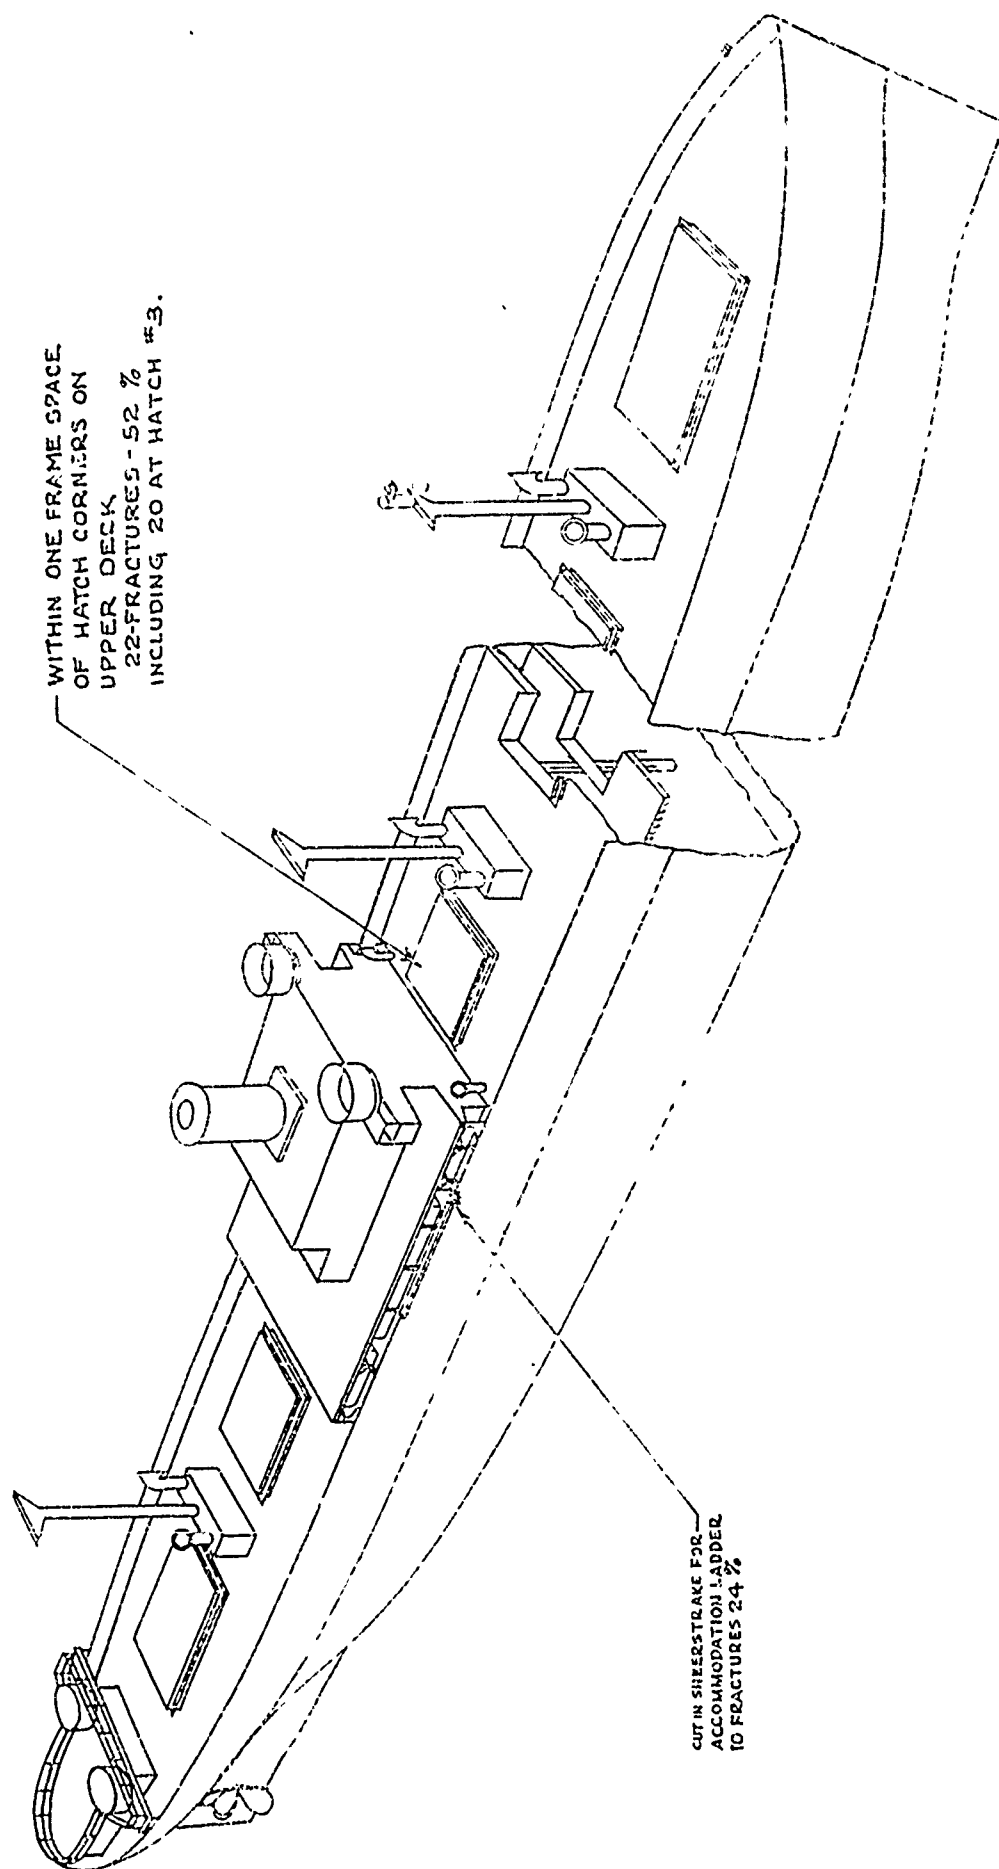
Figure 32

what different, figure 32. In many cases, the damage was so extensive that the starting point was not located. For this reason, it is only possible to identify positively the starting point of 31 casualties involving 42 fractures. Ten of these fractures or 24 percent started in the sheer strake cut for the gangway ladder. 22 or 52 percent started in the hatch corner including 48 percent at No. 3 hatch.

DETAILS WITH ABNORMAL FREQUENCY OF FRACTURES
THESE DATA INCLUDE, 4-2 FRACTURES OF KNOWN
ORIGIN, OCCURRING BEFORE 1 AUG 45, AND WHICH
RESULTED IN CLASS 1 CASUALTIES

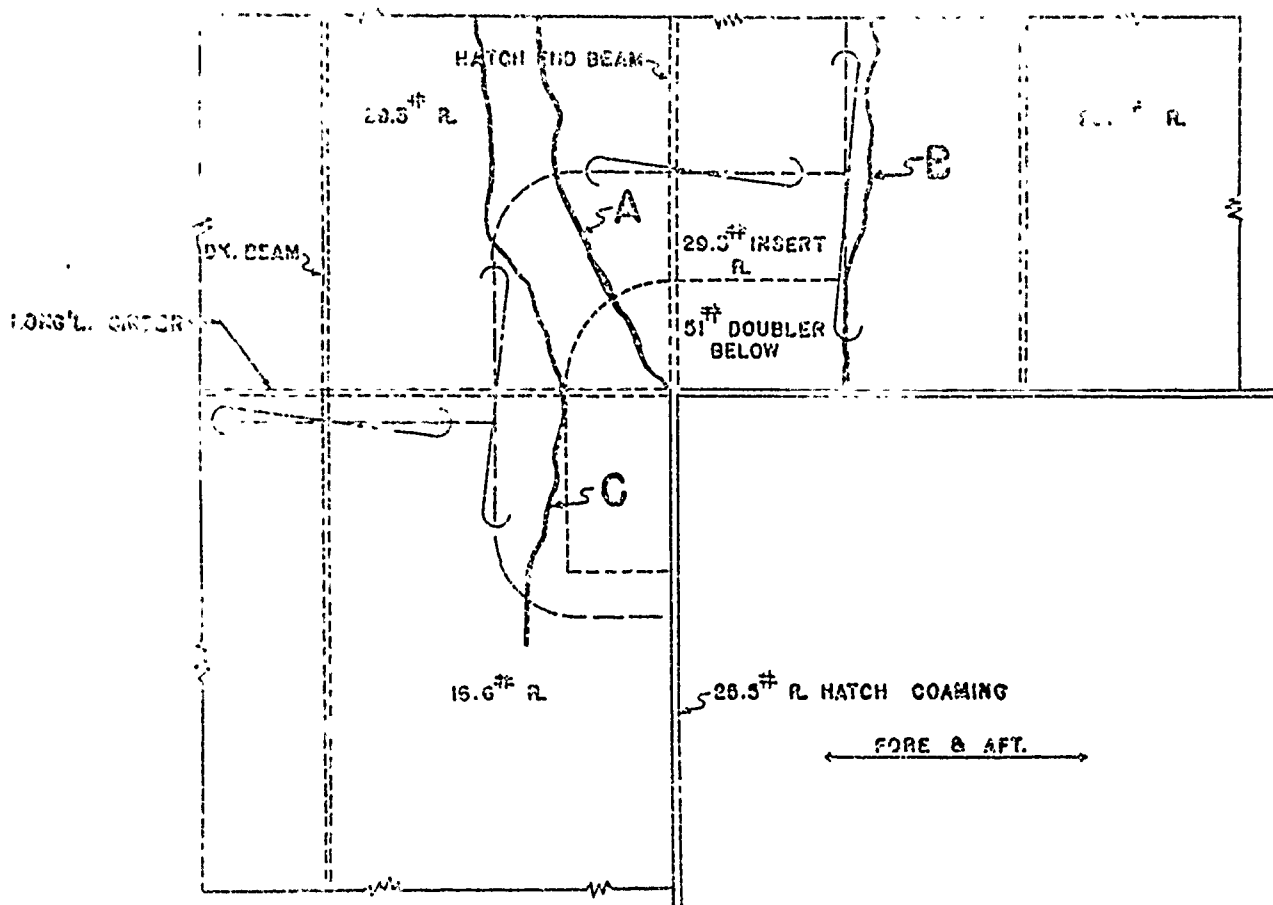
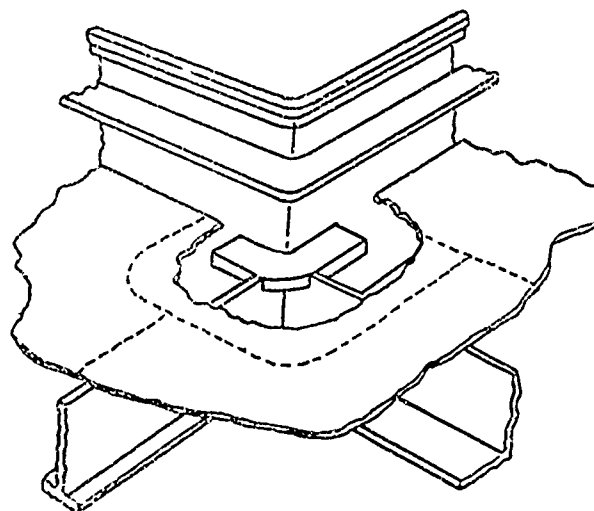
Figure 33.

Figure 33 shows the original design of the hatch corner and indicates the three most important sources of fractures. The greatest number of hatch corner fractures occurred in the manner indicated as A, second greatest as B, and there were several of type C. In the case of the type B fractures, there was involved a combination of design and workmanship. The abrupt end of the 51-pound doubler beneath the

SQUARE HATCH CORNER REINFORCED WITH DOUBLER

from hatch corner to gunwale would warrant grading the casualty Class 1. The Class 1 EC2 casualties include 67 fractures involving the hatch corner vicinity. Thirty-nine of these fractures are known to have originated in the hatch corner. A simple

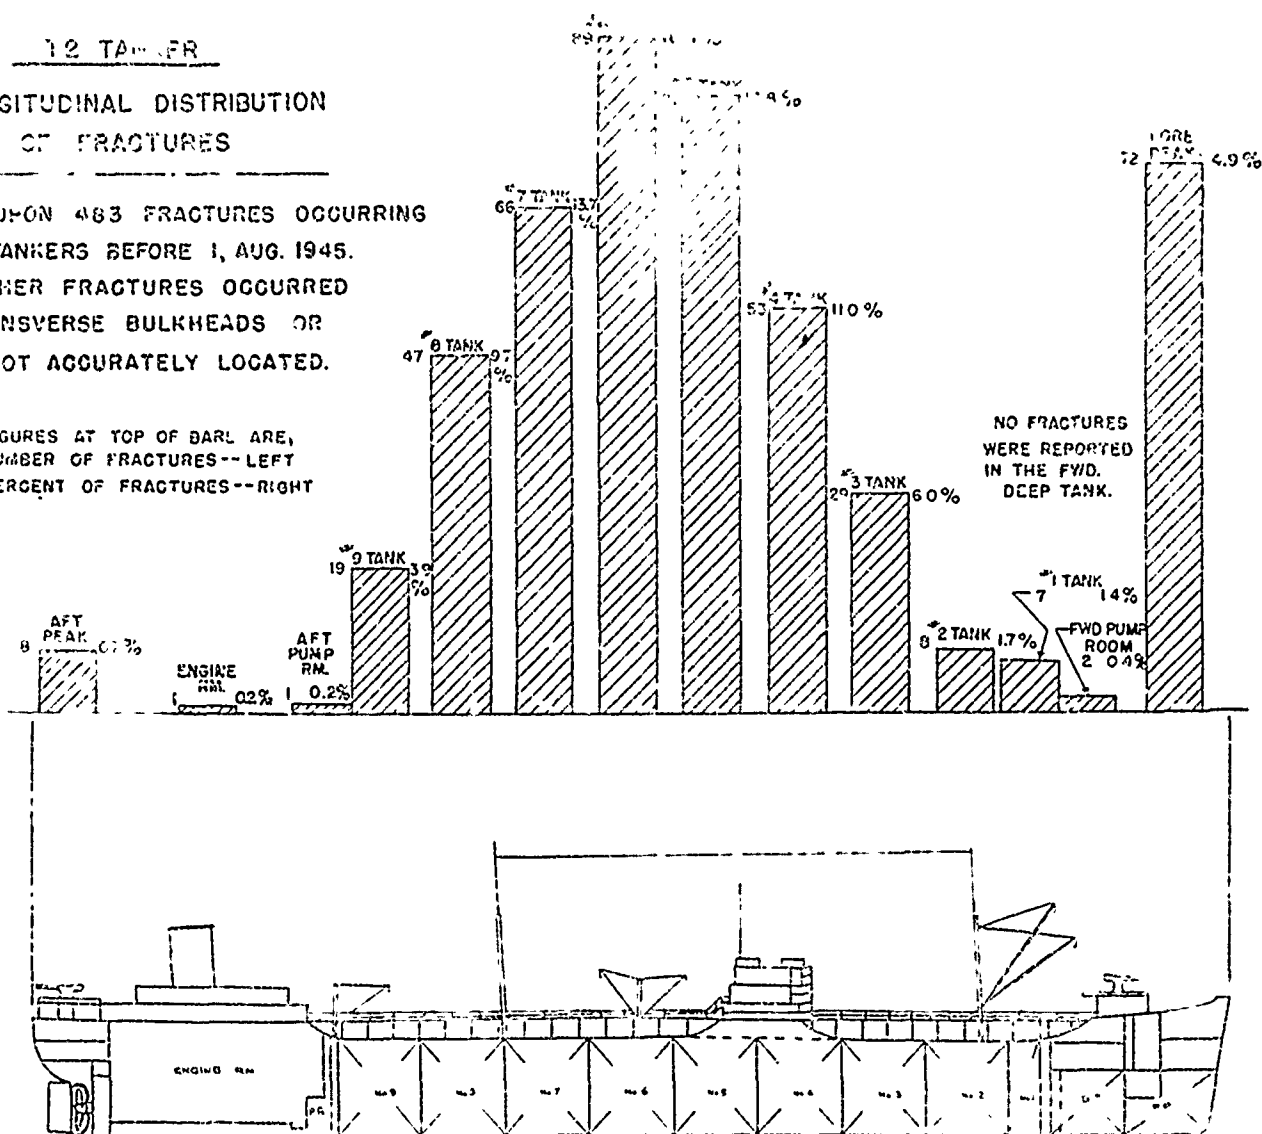
Figure 37.

BASED UPON 463 FRACTURES OCCURRING
ON T2 TANKERS BEFORE 1, AUG. 1945.
456 OTHER FRACTURES OCCURRED
ON TRANSVERSE BULKHEADS OR
WERE NOT ACCURATELY LOCATED.

The longitudinal distribution of the fractures on the T2 Tankers also shows a peak amidships indicating that bending of the hull is partly responsible for their occurrence, figure 37. All of the nine serious casualties occurred in Nos. 3, 4, 5, 6, and 7 tanks.

The large number of fractures in the forepeak indicated in figure 37 have involved many details of the internal structure. They are local in nature.

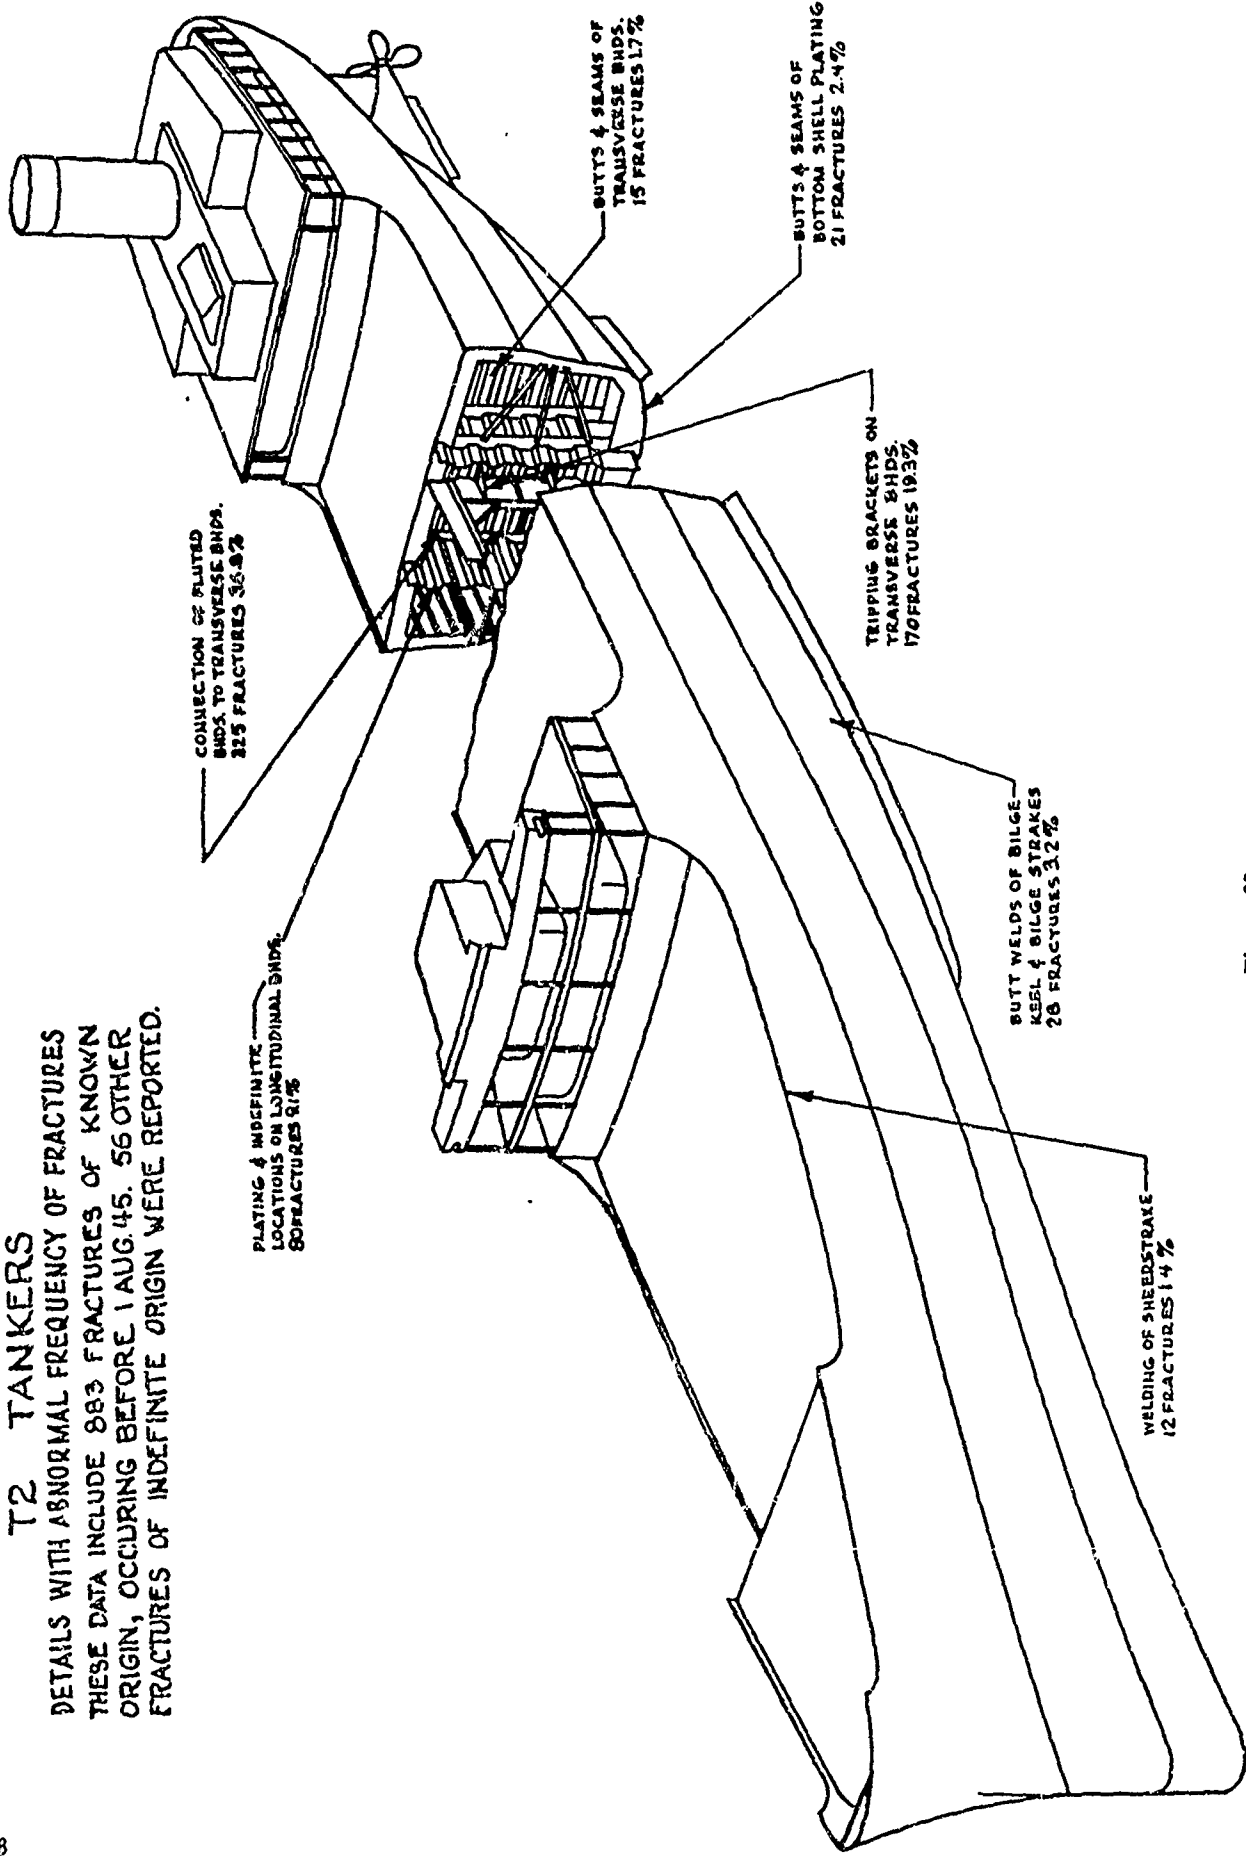
Figure 38.

T2 TANKERS DETAILS WITH ABNORMAL FREQUENCY OF FRACTURES THESE DATA INCLUDE 883 FRACTURES OF KNOWN ORIGIN, OCCURRING BEFORE 1 AUG. 45. 56 OTHER FRACTURES OF INDEFINITE ORIGIN WERE REPORTED.

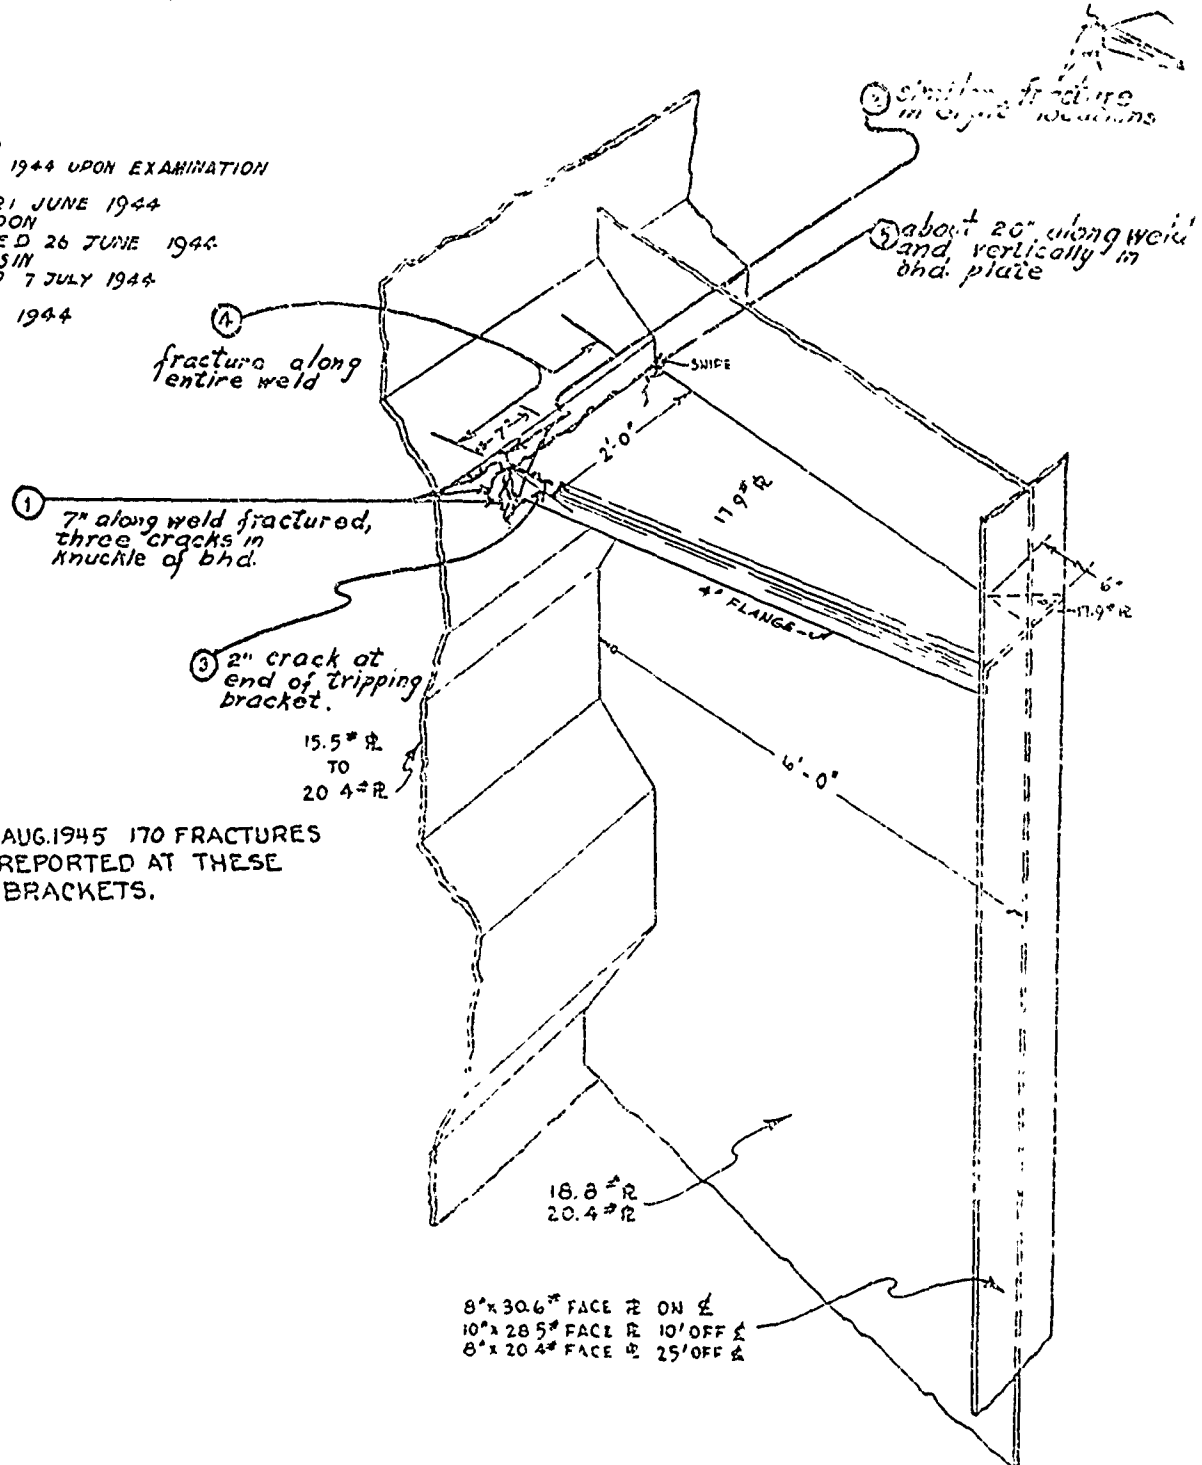
Figure 40.

One hundred and seventy fractures occurred at the toe of a bracket on the transverse bulkheads, figure 40. This is a design detail which can easily be cured and improved arrangements have been fitted in several vessels. A check on the longitudinal distribu-

T2-SE-A1 TYPE
COMPOSITE SKETCH OF FRACTURES
TRIPPING BRACKETS OF BULKHEAD STIFFENERS ON TRANSVERSE BULKHEADS

- ① NORTHFIELD
19 APRIL, 1944 UPON EXAMINATION
- ② RANIER
FOUND 21 JUNE 1944
- ③ NEW LONDON
REPORTED 26 JUNE 1944
- ④ RIVER RAISIN
REPORTED 7 JULY 1944
- ⑤ NEHALEM
AUGUST 1944

UP TO 1 AUG. 1945 170 FRACTURES
WERE REPORTED AT THESE
BRACKETS.

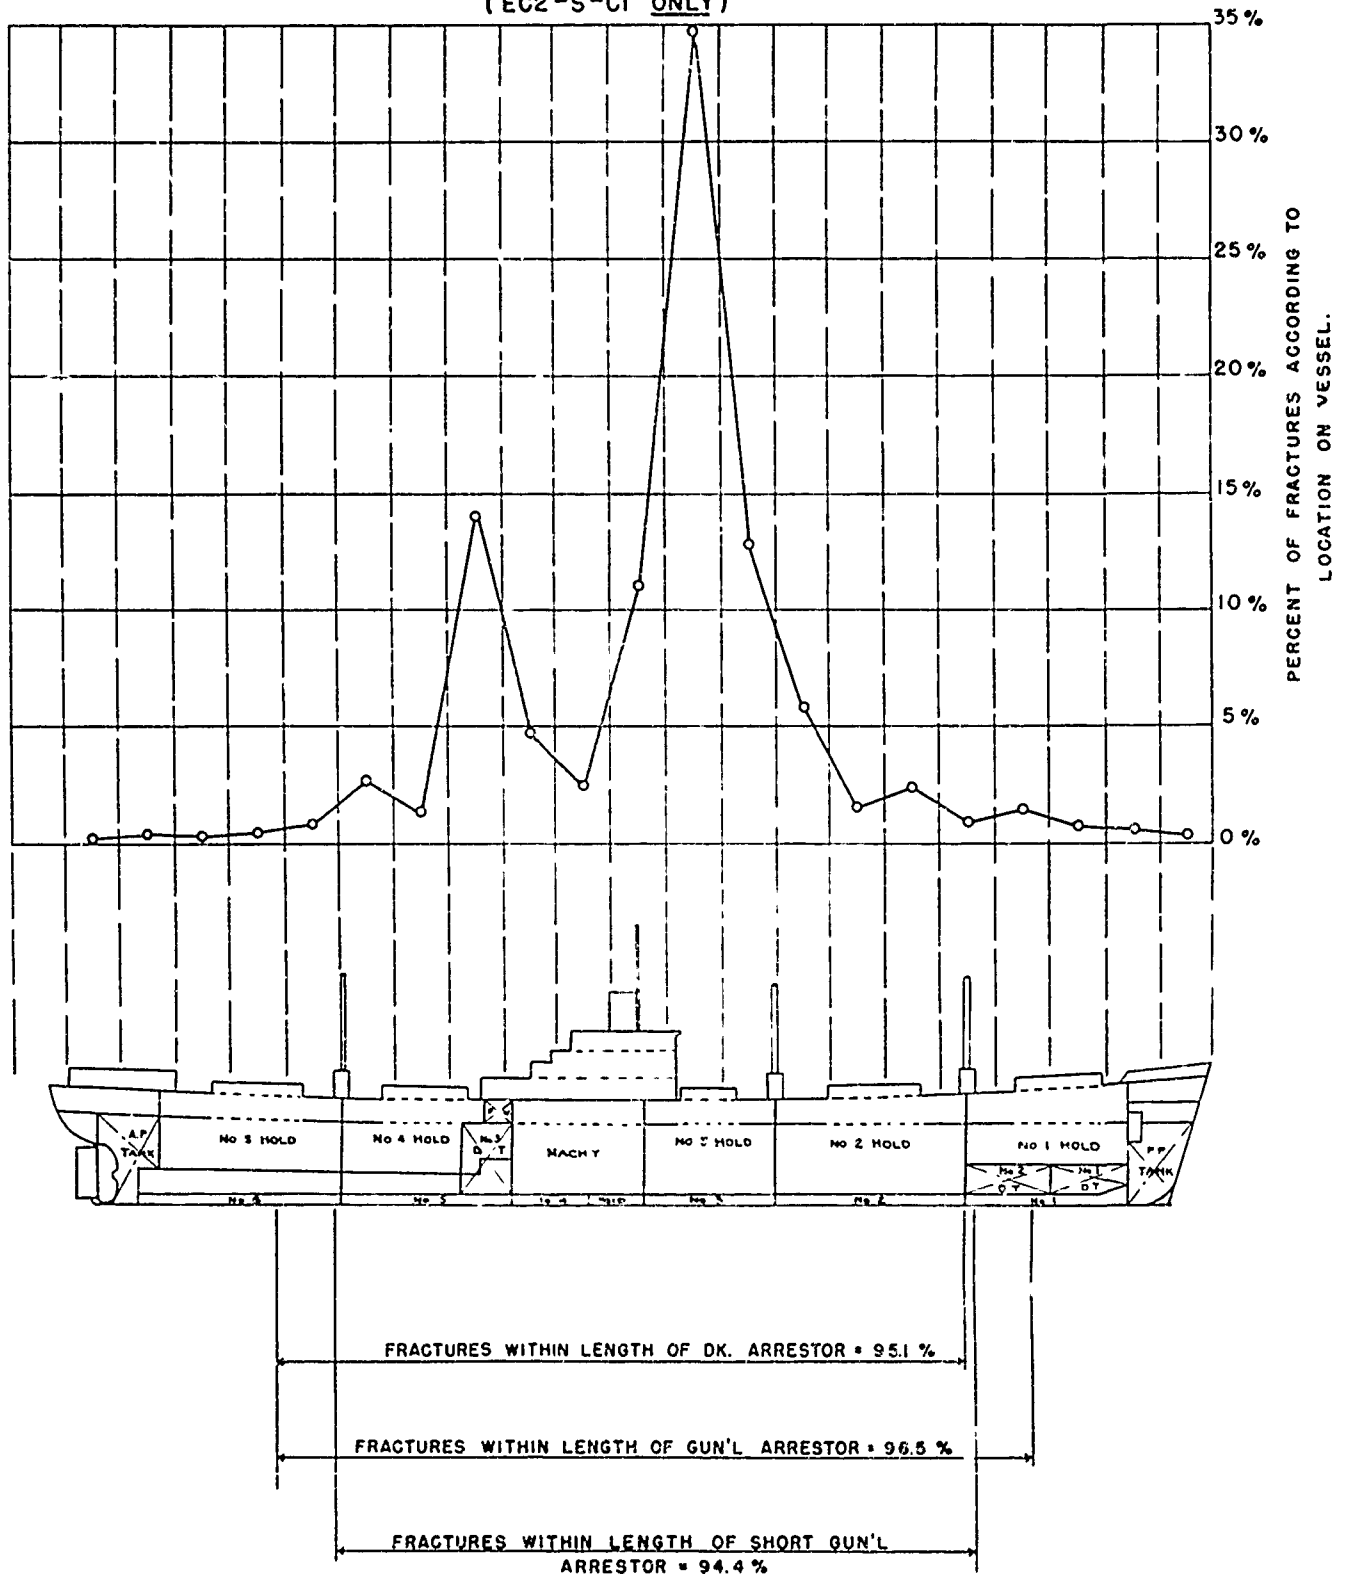
Figure 49.

THIS DRAWING IS BASED ON 1736 FRACTURES IN ALL PARTS OF LIBERTY SHIP STRUCTURE AND REPORTED BEFORE 17, OCT 1944

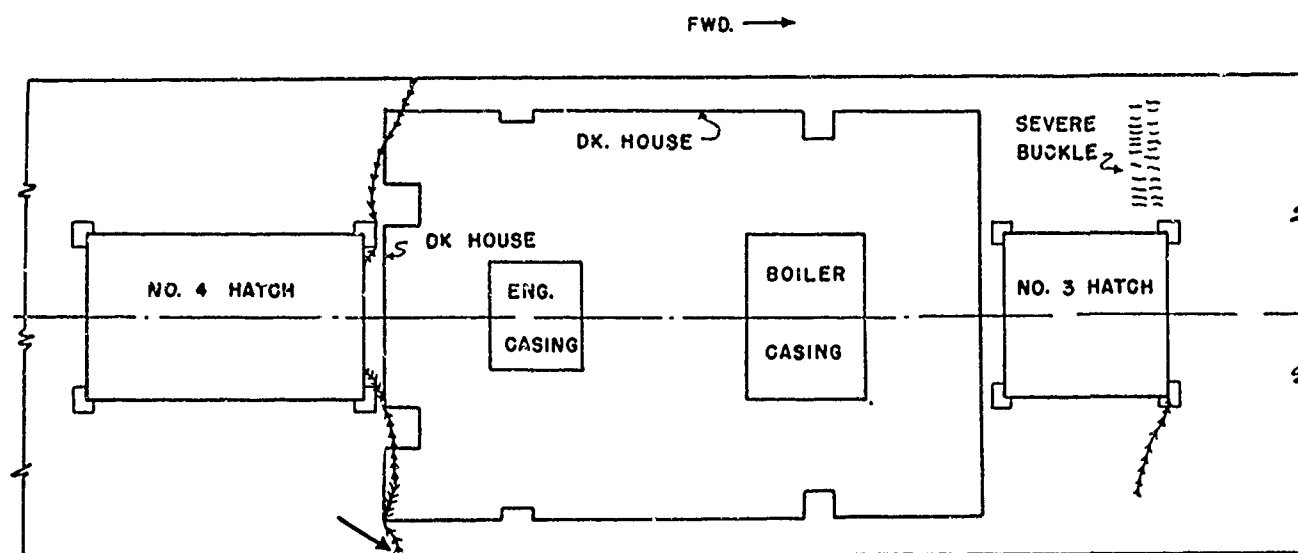
Figure 53.

Figures 53, 54 and 55 describe a typical case of an effective crack arrestor. The photographs were taken

S.S. COLIN P. KELLY JR.

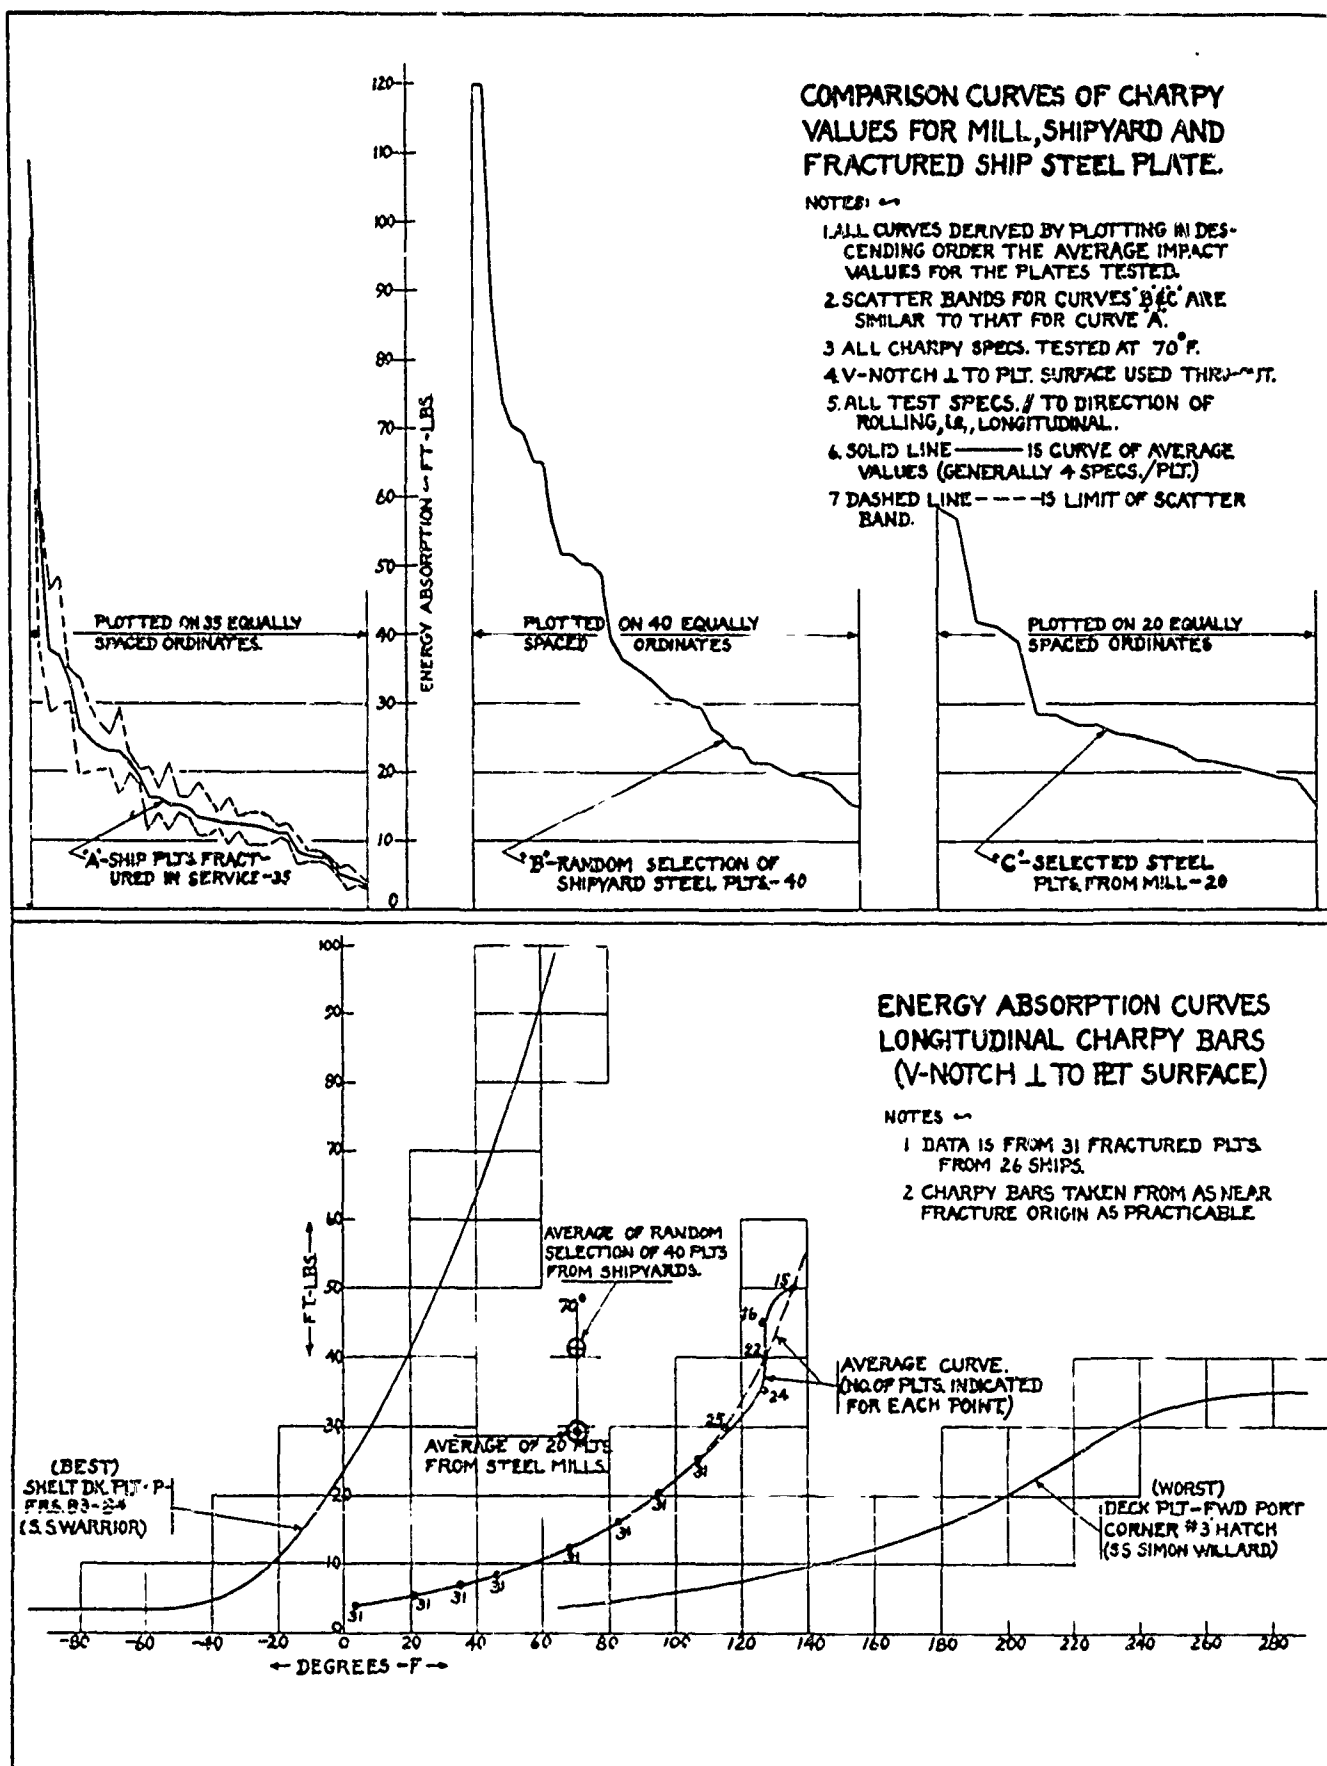
Figure 57.

Data for the 31 plates have been averaged with respect to temperature: the averages are shown in the lower portion of figure 57, along with the best and the worst curves. The energy absorption values at 70° F are also indicated for each of the plates tested (upper left) with dotted lines to indicate the spread of the energy absorption values covered by the four specimens tested at that temperature.

Data from Groups B and C have been entered in the temperature diagram on figure 57 and comparison suggests that specimens of steel in Group A (from fractured plates) were more notch sensitive than

Figure 57 shows that the steel in fractured plates loses the ability to absorb energy in the notched condition as temperature goes down. Low temperature is said to increase the notch sensitivity of the steel. Experience also shows that fractures in service gain in frequency at lower temperatures. It would be
